UNITED STATES AIR FORCE
AIRCRAFT ACCIDENT INVESTIGATION
BOARD REPORT

F-16CM, T/N 96-0085

DATE OF ACCIDENT: 7 JULY 2015

SUMMARY OF FACTS AND STATEMENT OF OPINION
F-16CM, T/N 96-0085
7 July 2015

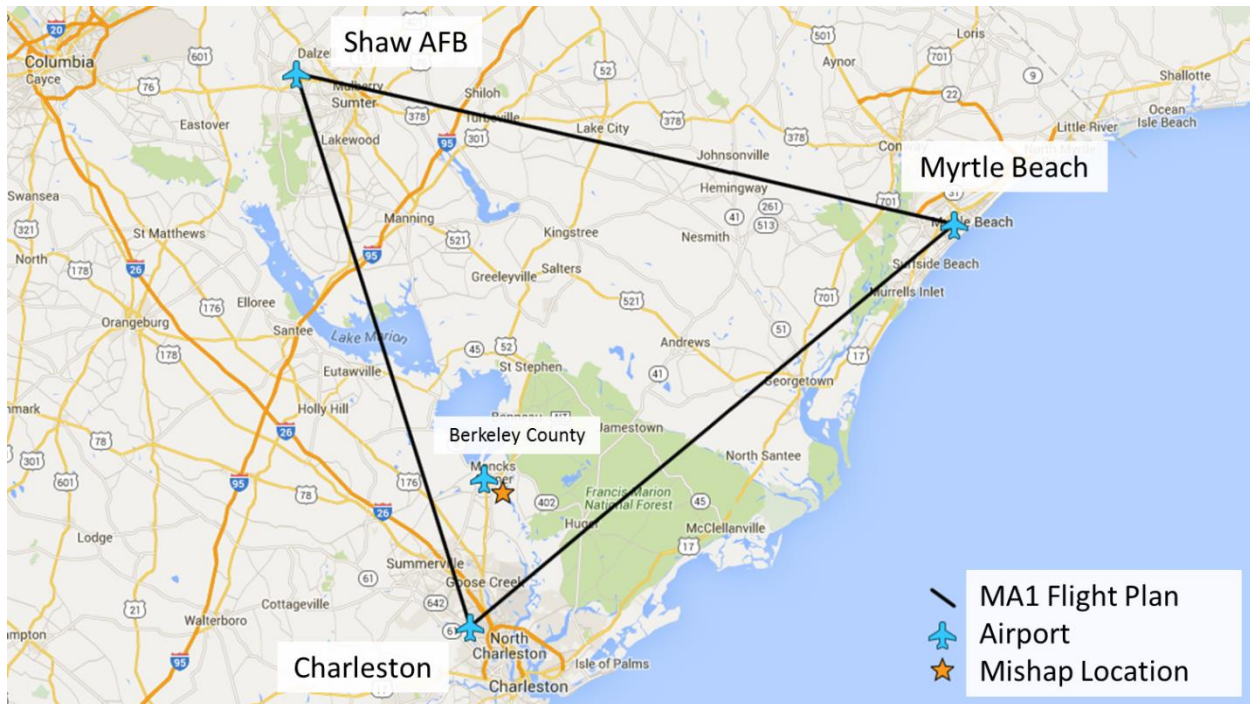
Figure 1: Overview of MA1 Flight Plan (Tab K-2). Map is from Google Earth. Lines do not represent actual flight path shown on MC's radar in Tab Z-17.

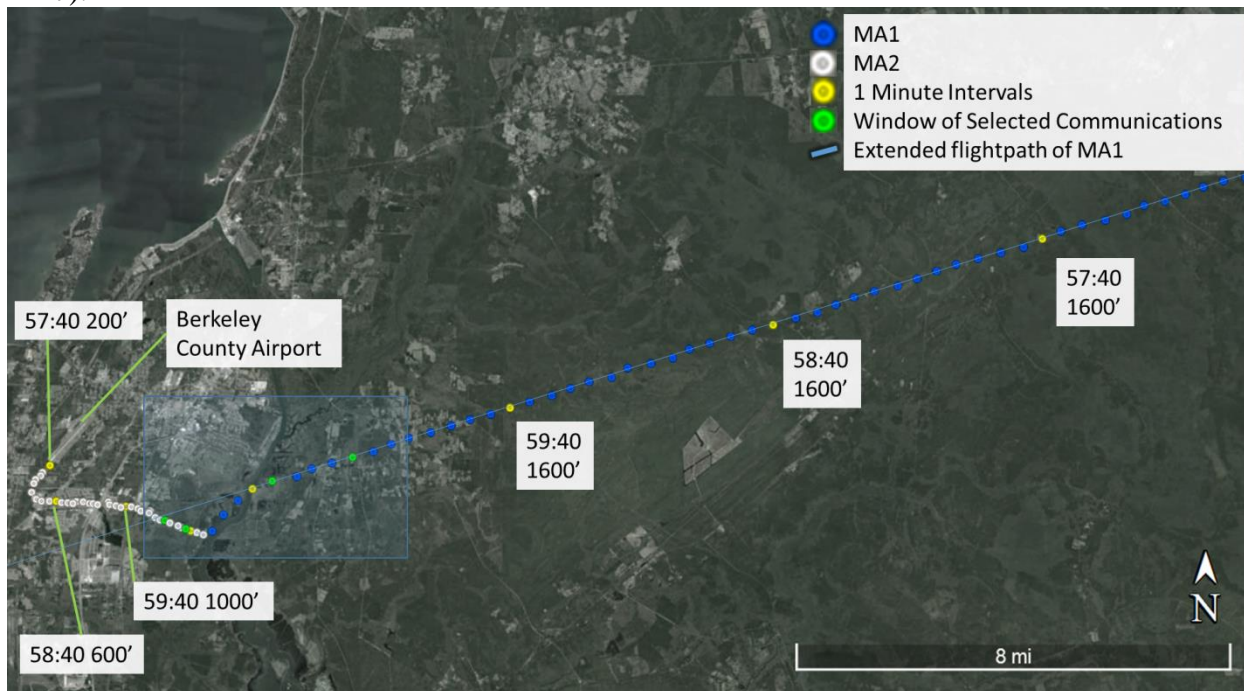
An overview of the ground tracks of both aircraft is in Figure 2 below (Tabs M-2, N-3 to N-5, and Z-17).

Figure 2: Overview of Air Traffic Control Radar Plots (Tabs M-2, N-3 to N-5, and Z-17). Each 1-minute interval starting with the first appearance of MA2 is yellow. Figure 3 expands the shaded rectangle. The locations of MA1 and MA2 during selected communications in Table 1 are green. Note: Figure 2 is not a depiction of actual MC radar displays.

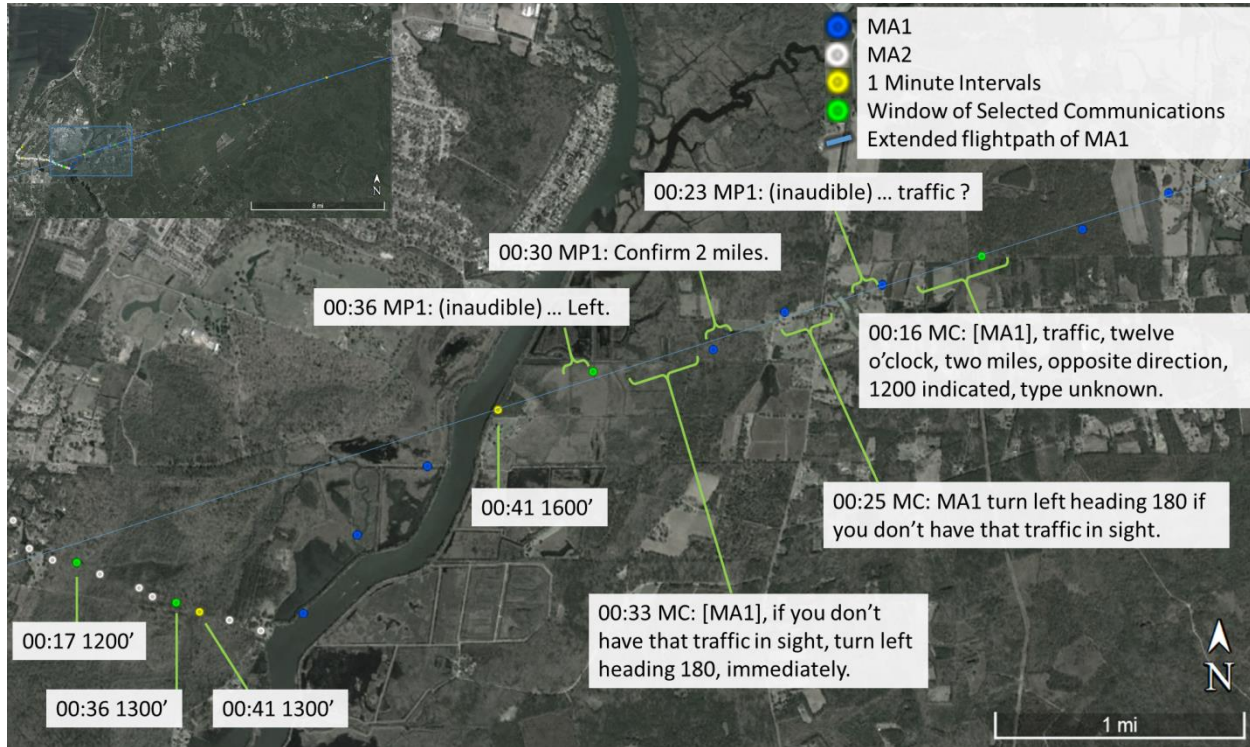
Figure 3: Expanded View of Air Traffic Control Radar Plots with Overlaid Communications (Tabs M-2, N-3, and Z-17). The brackets approximate the distance traveled by MA1 during the radio communications. During the depicted communications, MA2 was south of the blue line representing MA1’s extended flight path (260 degrees) and traveling further south away from MA1’s path (Tabs M-2, N-3, and Z-17). Not a depiction of actual radar displays.

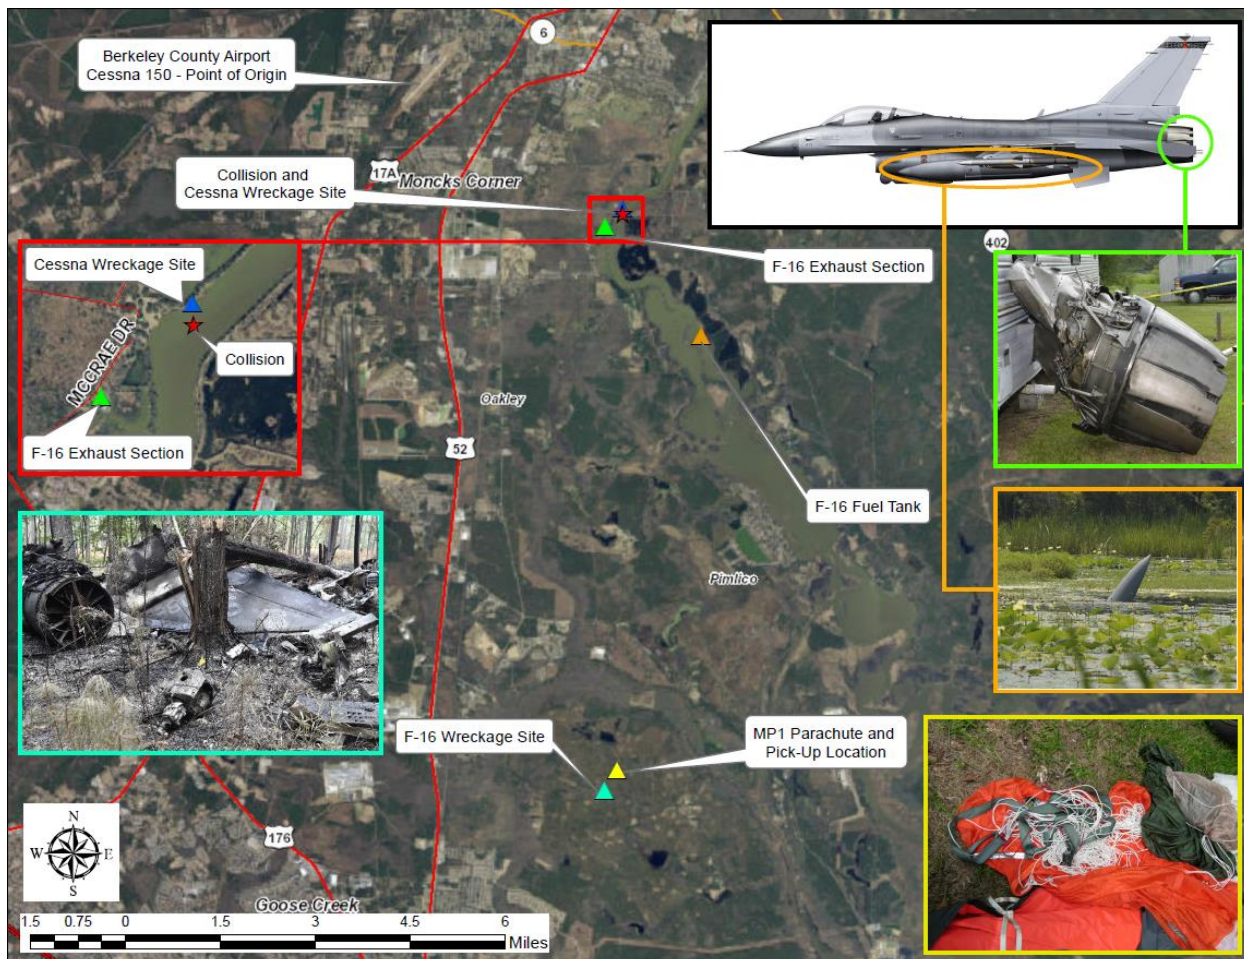
MP1 ejected at approximately 11:03L, about 300’ AGL (Tab H-8). MA1 was in a shallow decent and impacted an uninhabited forested area approximately 10 miles south of Moncks Corner, SC (Tabs H-4, Z-8, and Z-10). The majority of MA1 broke apart as it tumbled across the forest floor (Tab H-4). A post-crash fire further damaged parts of the wreckage (Tabs H-4 and S-4). The debris field, covered with medium-to-large fragments from MA1, measured approximately 200 yards long by 100 yards wide (Tabs H-4 , Z-2, and Z-8).

Figure 4: Post Impact Overview (Tabs H-2, Z-2, Z-8, Z-10, and Z-17)

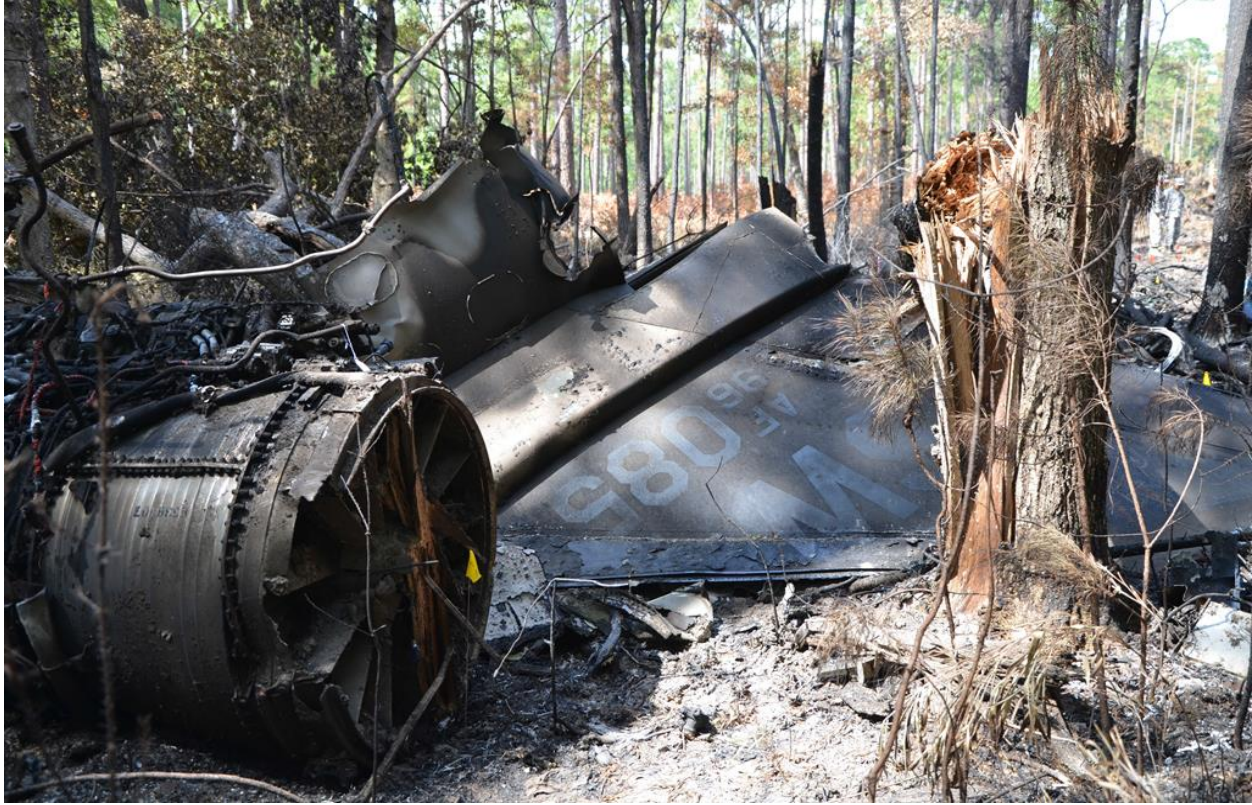
Based on the interview with MP1, there were no abnormal indications prior to the mishap to suggest MA1 was operating outside of normal parameters (Tabs U-28, and V-1.1 to V-1.15). The data collected from CSMU and SDR mirrors this information (Tab U-28). Lockheed Martin engineers evaluated the data from the SDR and concluded that the electrical system, hydraulic system and flight control system were operating normally prior to the mishap (Tab U-28). There is no evidence to suggest a pre-collision condition of MA1's structures or systems was a factor in the mishap (Tab U-28).

Figure 5: Post-ground impact MA1 wreckage (Tab S-4)

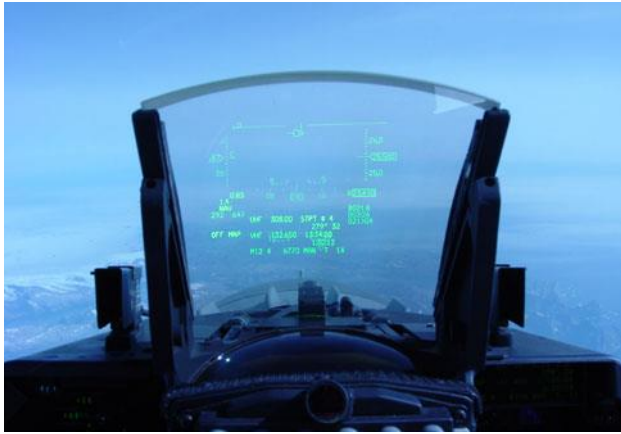
Anything that can interrupt direct line of sight, by such things ranging from aircraft structures to a bug splatter on a windscreen, can hamper a visual scan (Tab EE-9 and EE-14 to EE-30). At the extreme edges of influence, these can either block a pilot's vision or trap the eye, drawing a pilot's focus away from scanning (Tab EE-9 and EE-14 to EE-30; Figure 7).

Figure 7: Example of F-16 HUD

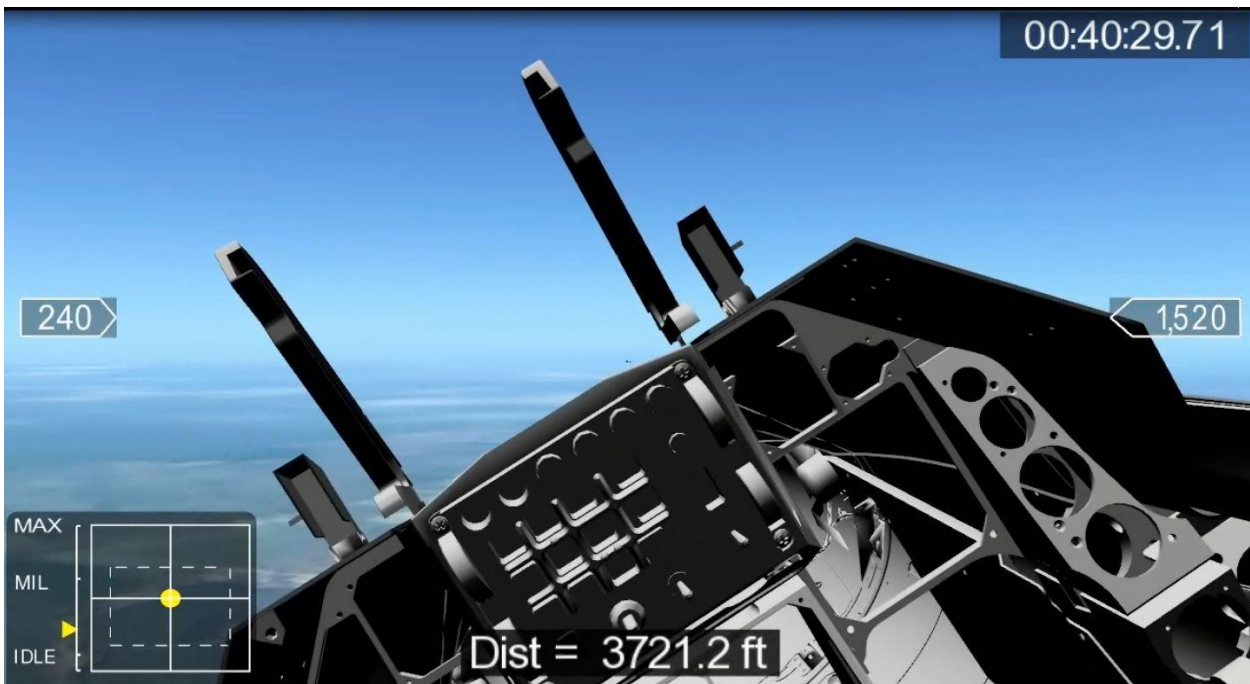
According to modeling, prior to the turn to 180 degrees, from a range of approximately 2 miles until 3400', MA2 was in front of MA1 and within the Head-Up Display (HUD) screen, which can display a significant amount of overlaid data (Tab Z-20; Figure 7). Inside of 3400', the bottom of the HUD and nose of the aircraft obscured MA2 from MP1's view (Tab Z-20; Figure 7). MP1 was looking under MA1 when MA2 came into view less than 500' away

[Figure 8: Simulated view from MA1 (without HUD overlaid data): MA2 appears in center of screen before becoming obscured. (Tab Z-20)

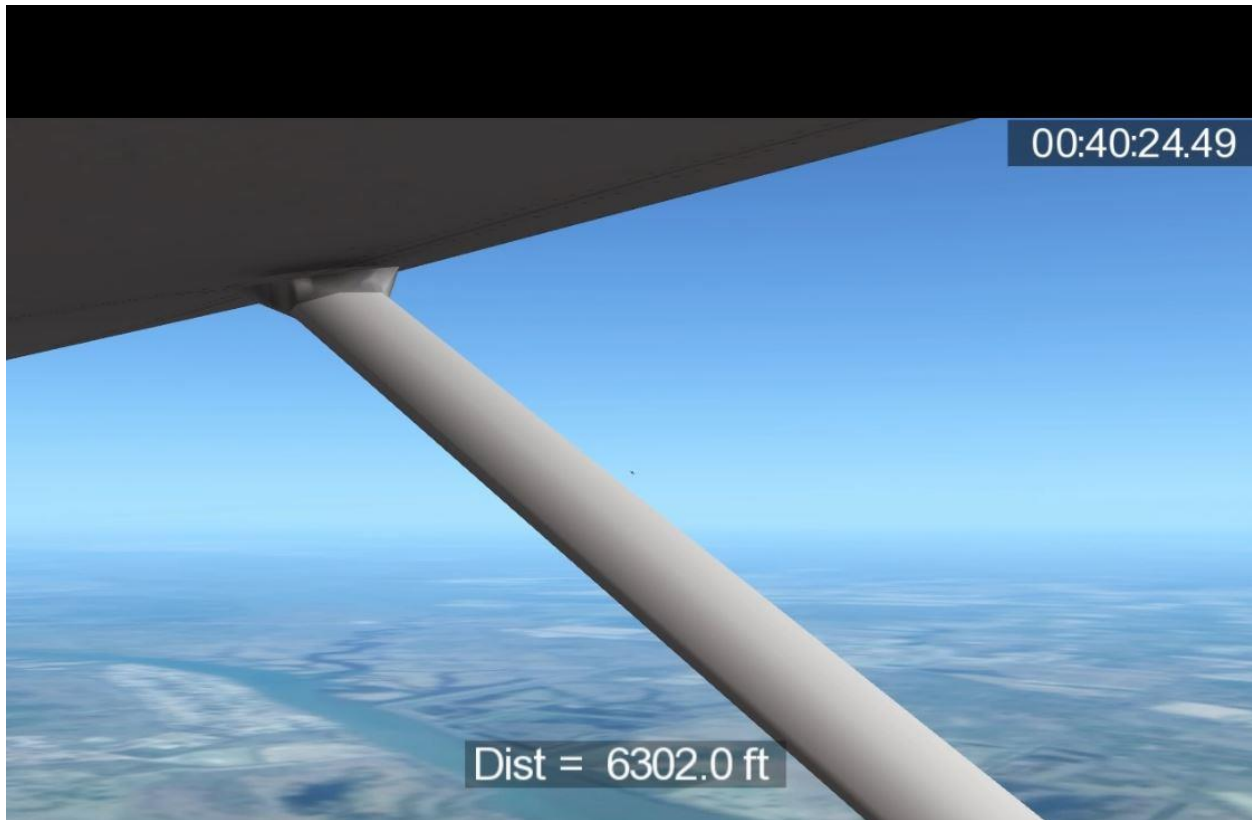
MA2 is a high wing aircraft with a prominent wing strut (Tab Z-19). Modeling reveals MA2's strut impeded MP2's vision of MA1 from approximately 1 mile away until immediately before impact (Tab Z-19).

[Figure 9: Simulated view from MA2: MA1 appears in center of screen before becoming obscured by strut (Tab Z-19)]

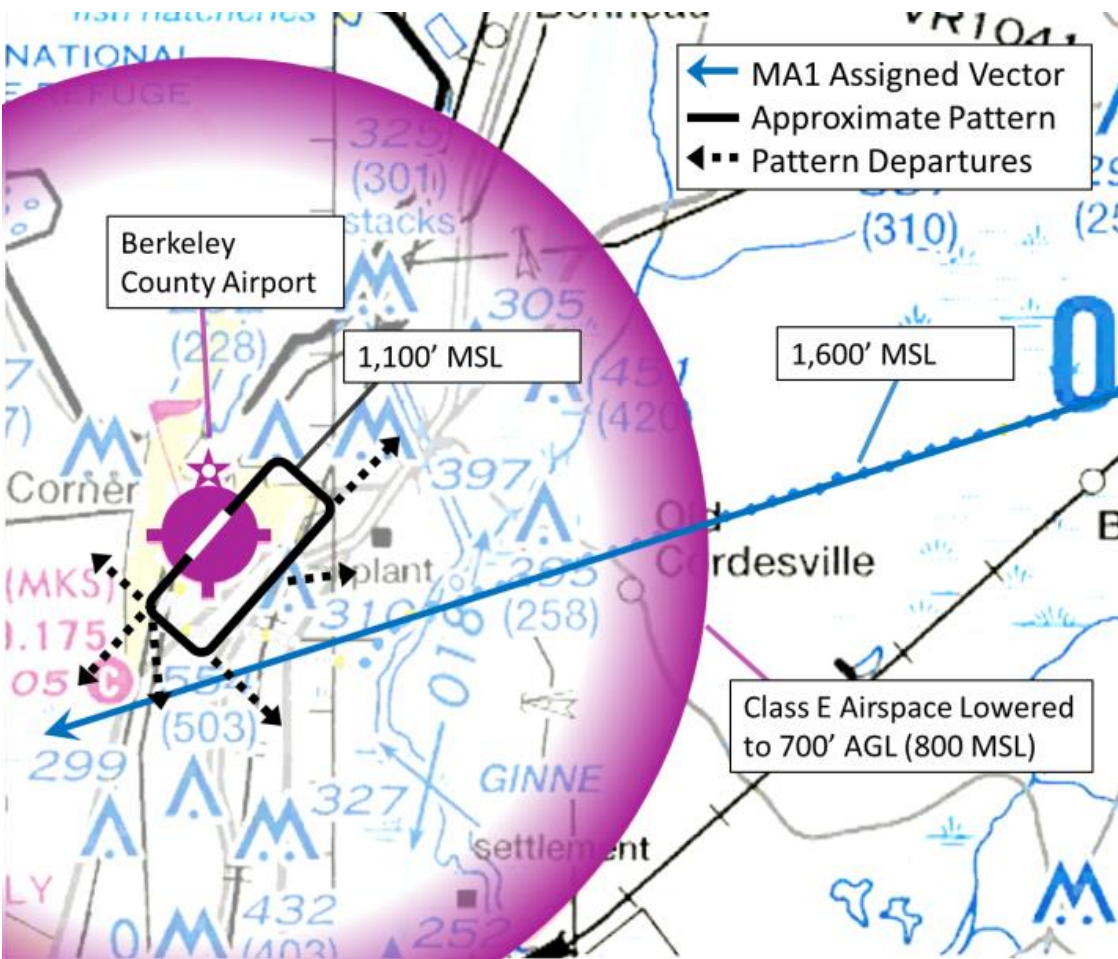
Figure 10: Overlay of KMKS Pattern and MA1 Vector on Sectional Chart (Tabs M-2, S-8, V-11.1, and Z-17). MA1 Assigned Vector (extended flight path) is from Figure 2. Class E Airspace lowers from 1200' to 700' AGL to transition instrument approaches into uncontrolled airfields without towers, such as KMKS (Tabs Z-11 to Z-12 and BB-125).

MC assigned MA1 a heading and altitude at the MVA of 1600' MSL (Tab GG-3). Without contact with MA2, MC could not validate MA2's altitude or verify MP2's intended flight path (Tabs N-3 to N-6, Z-17, and GG-3 to GG-5). Instructing MA1 to fly on a heading of 260 (southwest) placed MA1 on a course to cross roughly two miles south of the departure end of KMKS Runway 23 (Figure 10; Tabs Z-9, Z-17, GG-3 to GG-5). MC's heading and altitude placed MA1 within proximity of aircraft departure routes at KMKS (Figure 10).
